Figure 2a (to FER-113). Source data used in compilation of SSZ Map of Watsonville East quadrangle.

STATE OF CALIFORNIA SPECIAL STUDIES ZONES

WATSONVILLE EAST QUADRANGLE

REVISED OFFICIAL MAP

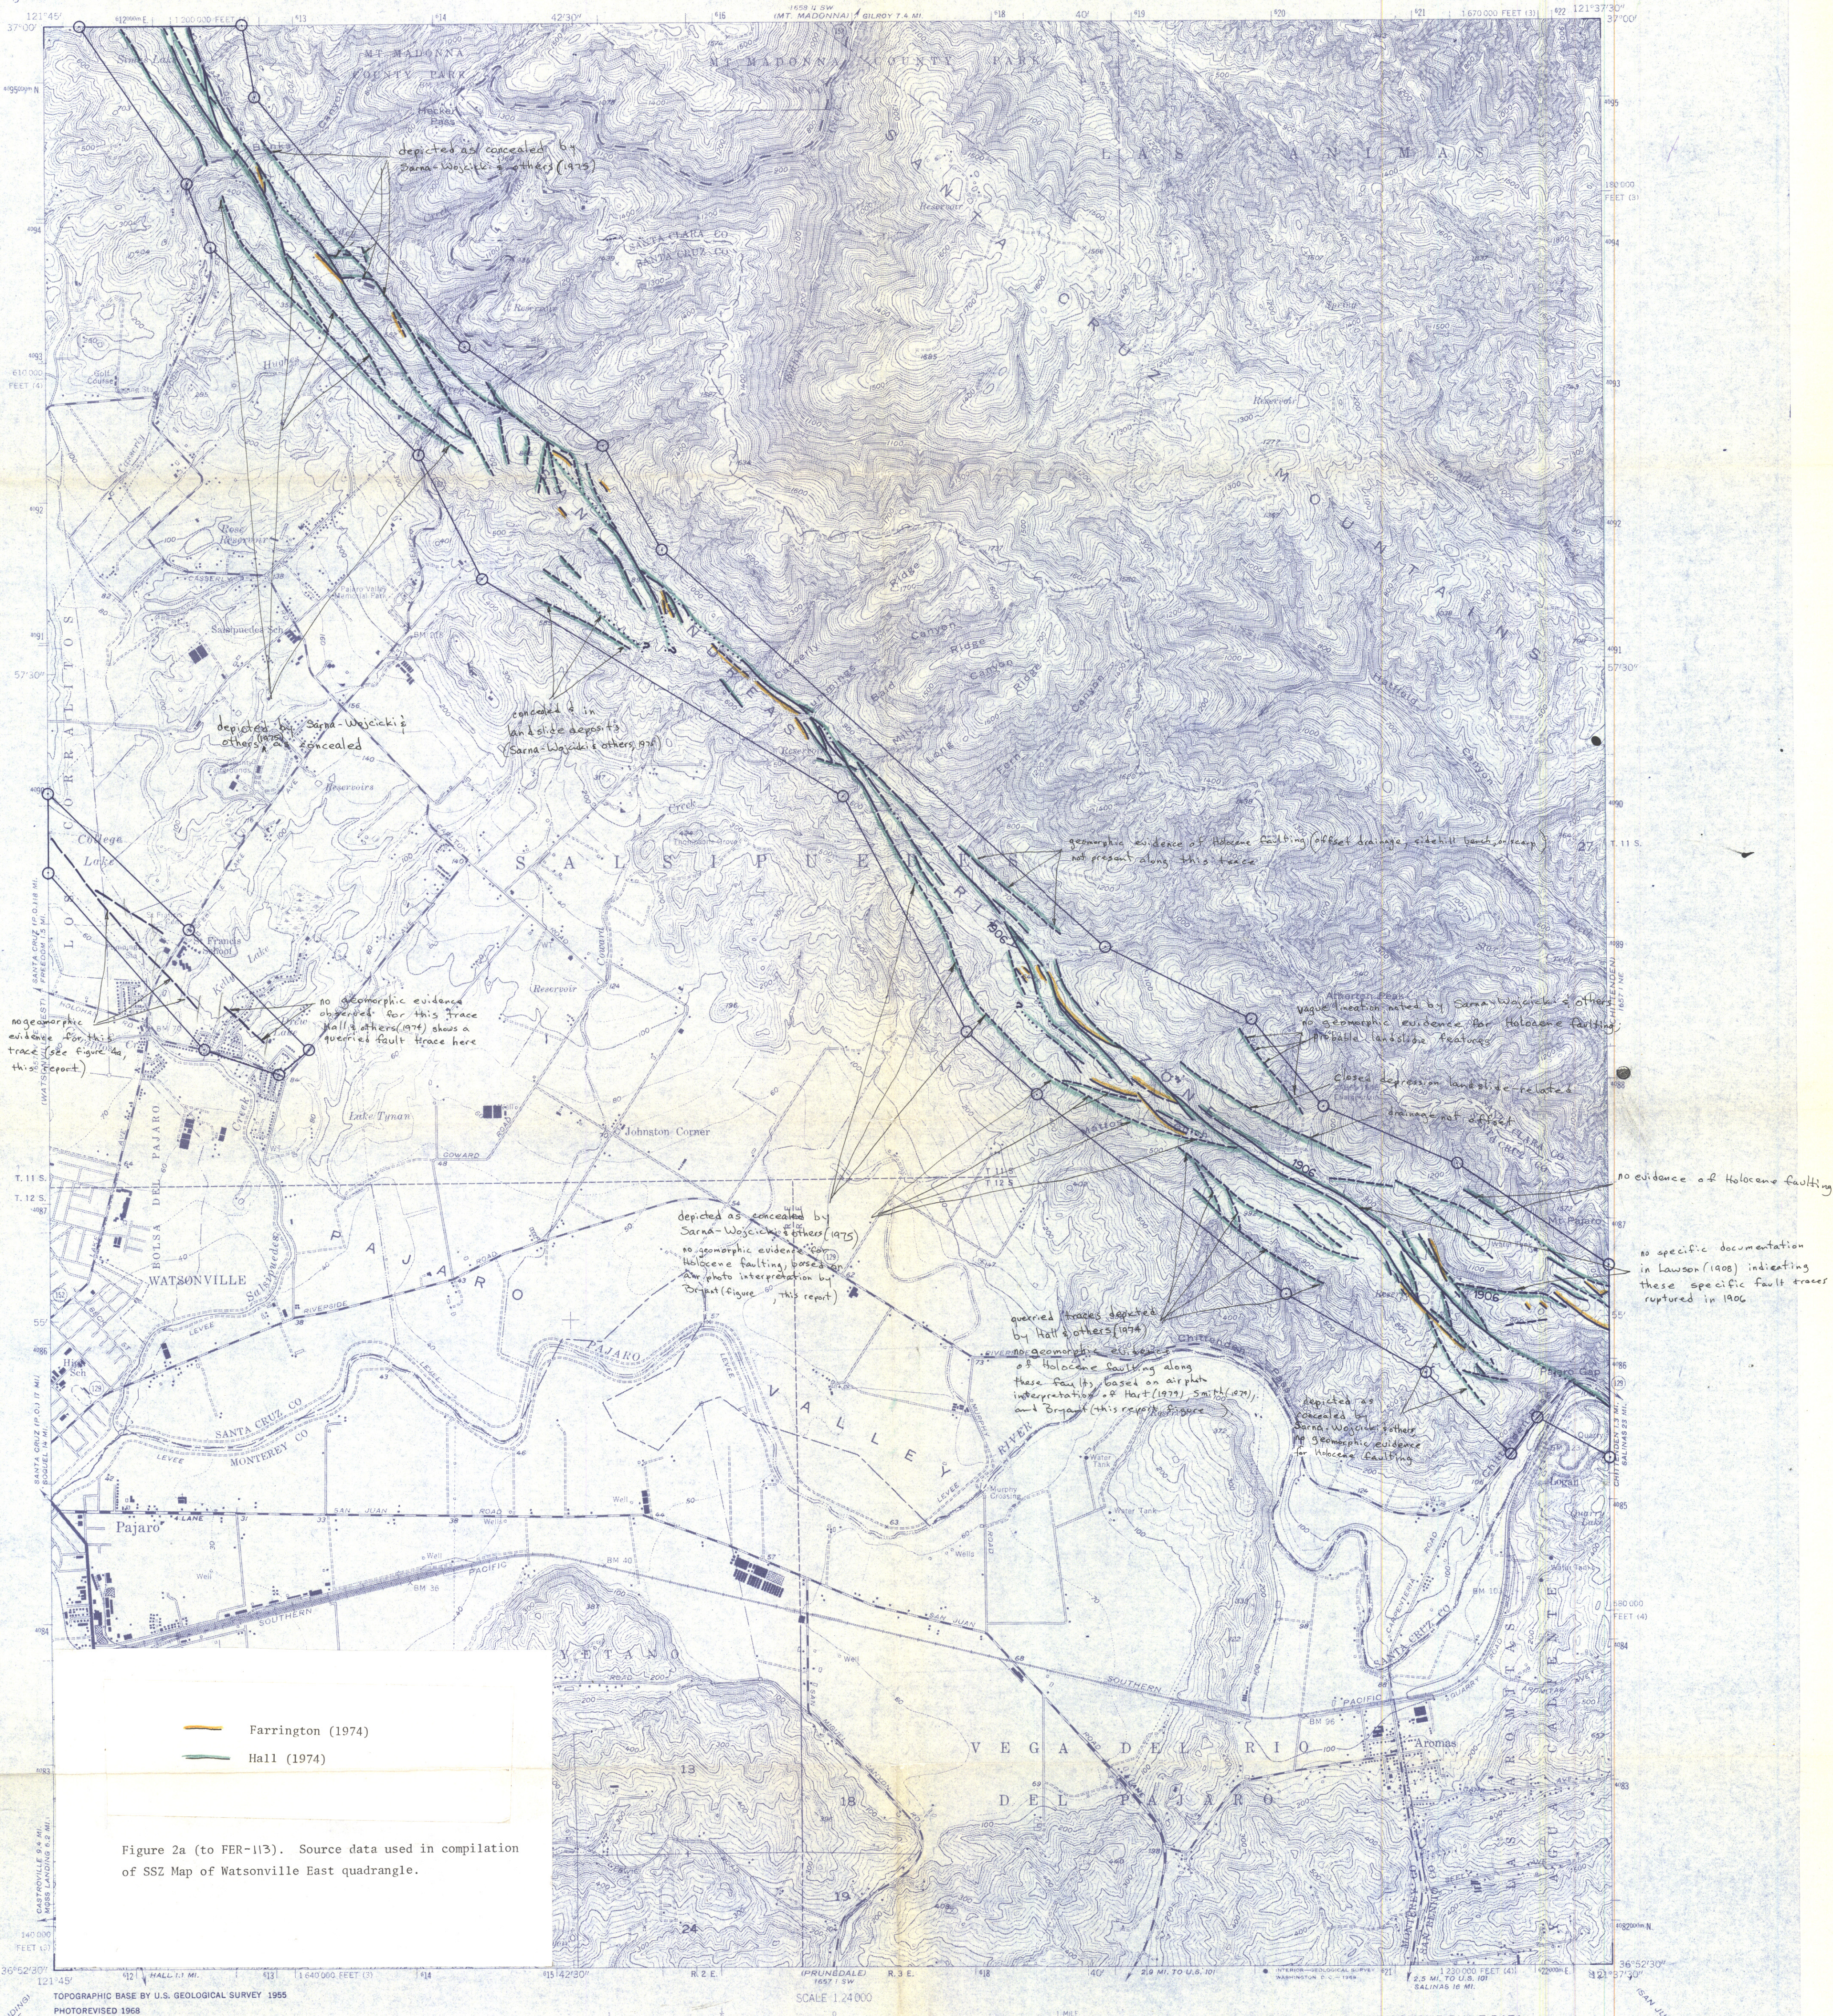
1906 C Faults considered to have been active during Quaternary time; solid line where accurately located, long dash where approximately located, short dash where inferred, dotted where concealed; query (?) indicates additional uncertainty. Evidence of historic offset indicated by year of earthquake-associated event or C for displacement caused by creep or possible creep.

Aerial photo lineaments (not field checked); based on youthful geomorphic and other features believed to be the results of Quaternary faulting.

These are delineated as straight-line segments that connect encircled turning points so as to define special studies zone segments.
